Proceedings of the 9ICEG
9th International Congress on Environmental Geotechnics
25-28 June, 2023 | Chania, Greece
© Authors: All rights reserved, 2023
https://doi.org/10.53243/ICEG2023-279

An Investigation of Field Performance of Geomembrane-Geosynthetic Clay Liner Landfill Bottom Lining Systems

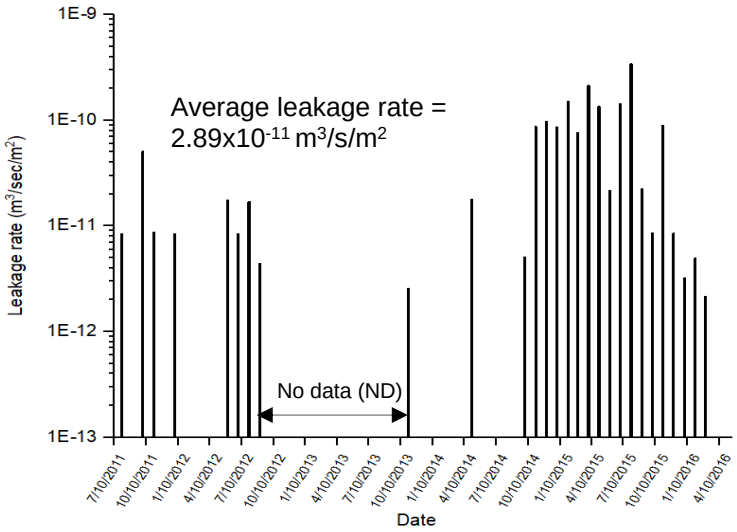
Figure 3 shows the observed field leakage rate for Cell 1 (Landfill A, GM-GCL). The average leakage rate obtained during the period was 2.89×10^{-11} $m^3/s/m^2$ with a standard deviation of 6.29×10^{-11}. The maximum leakage rate observed was 3.44×10^{-10} $m^3/s/m^2$.

Figure 3. *LDS leakage rate for Cell 1- Landfill A (GM-GCL lining system)*

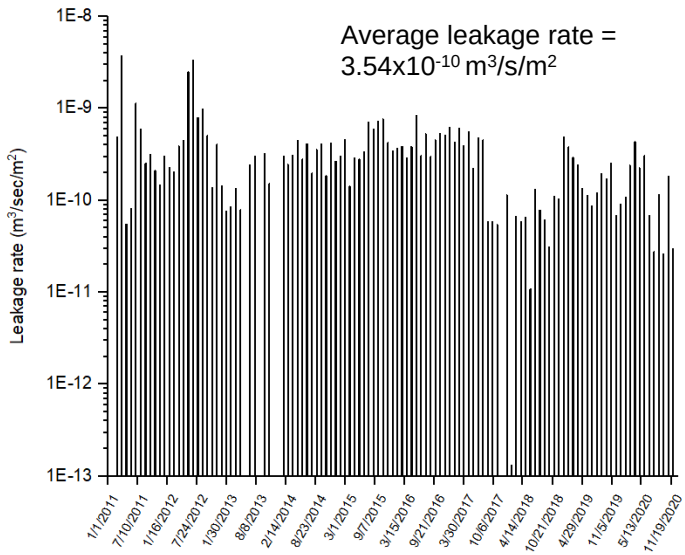
For the landfill with the Florida double lining system, an average leakage rate of 3.54×10^{-10} $m^3/s/m^2$ with a standard deviation of 5.17×10^{-10} was obtained (Figure 4). The maximum leakage rate observed was 3.72×10^{-9} $m^3/s/m^2$. The average leakage rate for Cell 2 (Landfill B, Florida double liner) was an order of magnitude higher than that observed from Cell 1 of Landfill A.

Figure 4. *LDS leakage rate for Cell 2- Landfill B (Florida double lining system))*

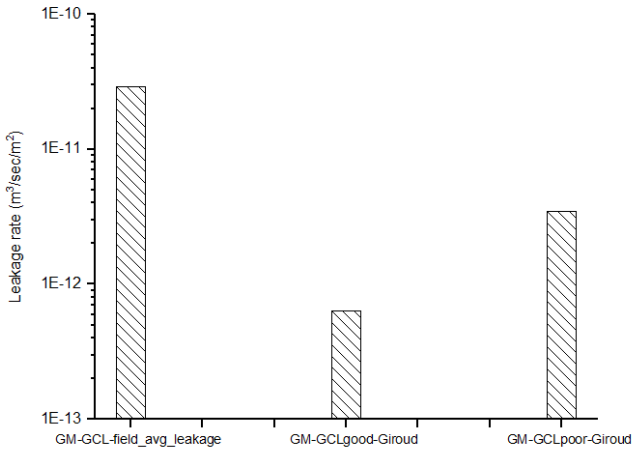
Figure 5 shows a comparison between the average field leakage rate for Cell 1 of Landfill A (GM-GCL) and the theoretical leakage rates computed using Equations 1 and 2. The average field leakage rate is an order of magnitude higher than the leakage rate computed using the poor contact interface condition scenario and two orders of magnitude higher than the good contact condition scenario. This implies that the leachate volumes pumped from the LDS of Cell 1 (landfill A, GM-GCL) are much higher than those computed theoretically to predict leakage rates.

Figure 5. *Comparison of the average field leakage rate for Cell 1 (Landfill A, GM-GCL) and the theoretical leakage rates (good and poor contact) using equations 1 and 2*

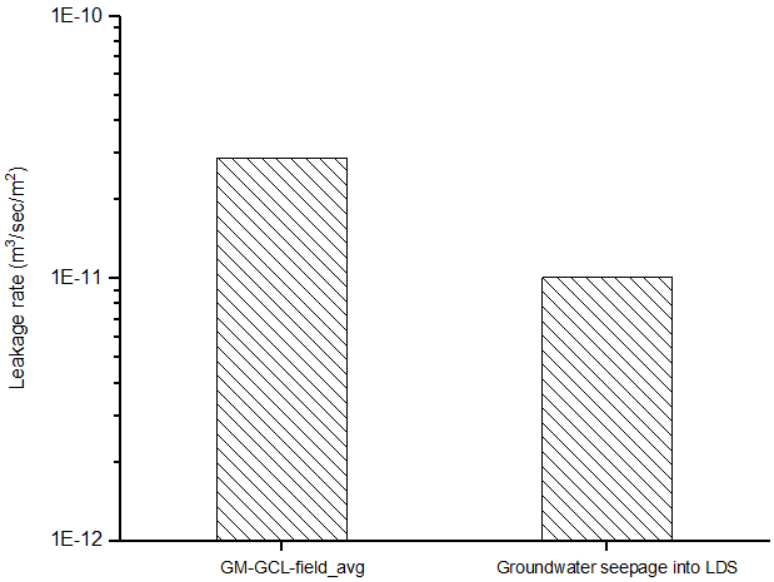
GM-GCL system, leakage through the GCL is only limited to areas where there are defects in the GM. The Darcy's law and Equation 3 can be used to approximate the rate of seepage of groundwater into the LDS. To compute the groundwater intrusion into the LDS, the groundwater level was taken to be 0.3 m above the GCL elevation, which translates into an upward pressure of 2.943 kPa. Applying an upward groundwater pressure of 2.943 kPa to the GCL, an approximate leakage rate of 1.01 x 10^{-11} $m^3/s/m^2$ is obtained in the LDS. A comparison of the leakage rate computed as a result of the upward groundwater pressure and the average field leakage rate for Cell 1(GM-GCL double composite liner) is shown in Figure 6.

Figure 6. *Comparison of the average field leakage rate for Cell 1 (Landfill A, GM-GCL double composite liner) and groundwater seepage into the LDS.*
