Proceedings of the 9ICEG
9th International Congress on Environmental Geotechnics
25-28 June, 2023 | Chania, Greece
© Authors: All rights reserved, 2023
https://doi.org/10.53243/ICEG2023-428

Geotechnical and Geo-Environmental Damage and its Impacts on Critical Community Infrastructure during the 2021 Western European Floods: The Case Study of Altenahr, Germany

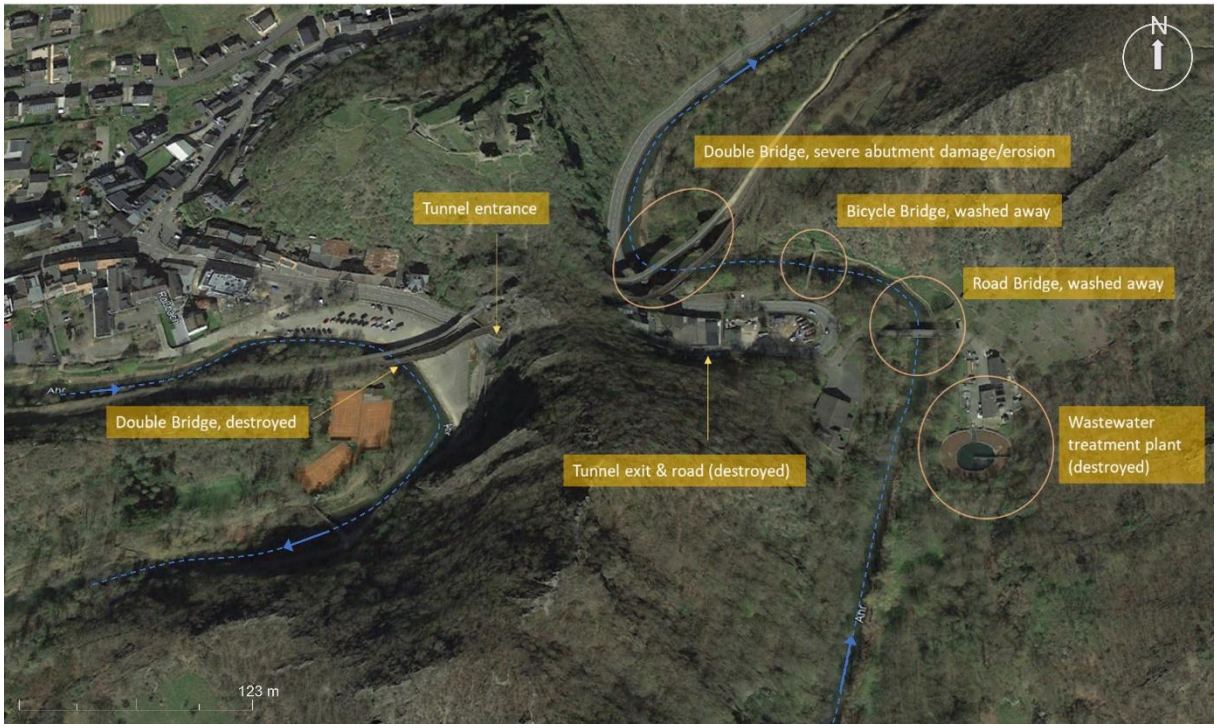
The tunnel exit site in Altenahr has been one of the most featured damage locations of the Ahr valley in Germany. Figure 7 shows an aerial map obtained from Google Earth and various infrastructure facilities near the affected site. This location is of particular interest for documenting how soil relocation near the tunnel and intersection with the Ahr river relate to local hydraulics, geology, and abundant infrastructure. The location features multiple key infrastructure items forced to be tightly grouped due to the restrictive, steep valley, and the river. The presence of this infrastructure, in particular the tunnel, led to a significant change in local hydraulics.

The *Ahr* river makes a bend around the tunnel (which is located south of the photo, but not visible in Figure 7). Aside from the tunnel entrance and exit areas, Figure 7 also describes the infrastructure around the tunnel and its performance during the flood. Flood waters flowed through the tunnel from the tunnel entrance on the west side, nearly filling the opening cross-section. The relatively small cross-sectional opening of the tunnel caused a high-velocity water efflux that exited on the east. The double bridge (rail/bicycle) on the west side of the tunnel was also destroyed during the flood.

Figure 7. *Google Earth Aerial View of the tunnel entrance/exit site in Altenahr prior to the flood (3/2020).*

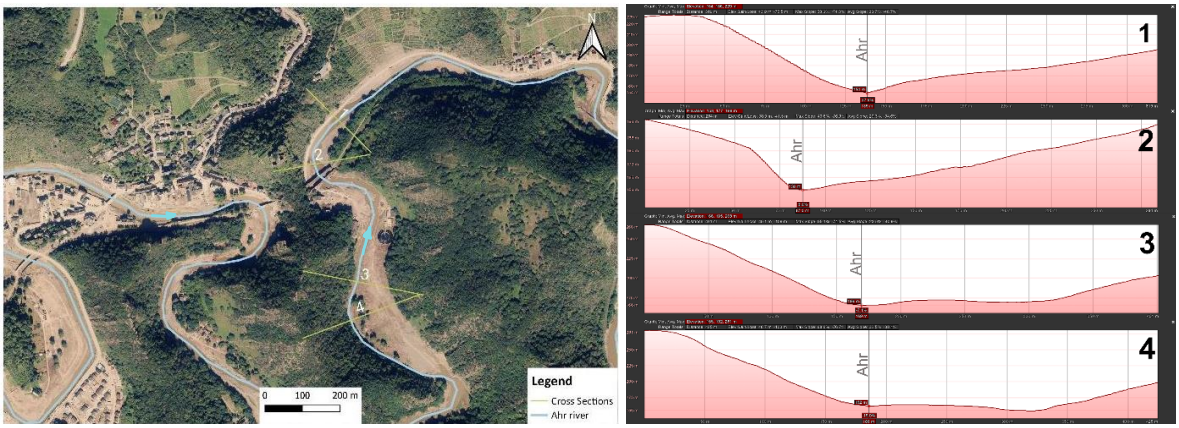
Near the tunnel exit, a double bridge connected railway tracks and a road across the Ahr river. Figure 9 shows the severe damage to both bridges, but also the extent of sediment relocation and streambed destruction at this location. The image also illustrates a key geological and topographic characteristic of the Ahr valley: its steep slopes and limited width of the river valley. This topography has been highlighted as a key issue that led to the severity of the flood in the Ahr valley. Figure 10 shows an elevation profile at the location of the double bridge and surrounding area. The bridge is situated near profile #2 in Figure 10 (right). The maximum slope of the adjacent hillside was approximated as 76.9% (cross-section 2). Figure 10 also illustrates the extent and width of soil erosion and sediment redeposition along the Ahr river in the vicinity of Altenahr (Fig 10, left).

Figure 10. *Left: Plan view of tunnel exits and location of cross-sections; Right: Elevation profiles in near vicinity of the Altenahr tunnel exit*

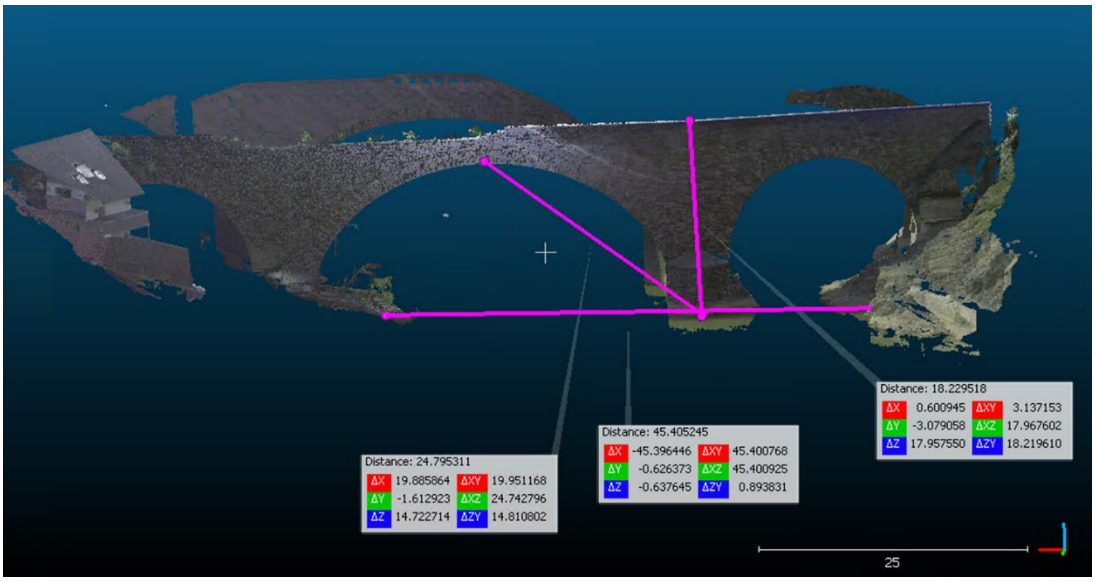
Figure 15 depicts an excerpt of initially collected 3D point cloud data of the double bridge using terrestrial LiDAR. Data processing from this location (as well as most others) is still ongoing. The generation of the point cloud model from terrestrial LiDAR allows for geometric measurements of features of interest. As shown in Figure 15, estimates of the total bridge height, clearance height, and cross-sectional distance of the river were found to be 17.96m, 14.72m, and 45.50m respectively. Similar measurements are possible in point clouds generated from UAV imagery, albeit with less accuracy. Aside from measurements depicted in Figure 15, possible future geometric measurements include volume of soil lost due to scour and erosion, angle of pier tilt, deck deflection, and the dimensions of resulting cracks in decks or piers. These data provide meaningful information for numerically modelling water-structure-soil interaction at the bridge location.

Figure 15. *3D point cloud excerpt derived from terrestrial LiDAR at the Altenahr double bridge.From left to right, measurements of the bridge clearance height (delta Z = 14.72m), river cross sectional distance (delta X = 45.50m), and total bridge height (delta Z = 17.96m) were measured using the LiDAR derived point cloud.*
