**Proceedings of the 9ICEG**
9th International Congress on Environmental Geotechnics
25-28 June, 2023 | Chania, Greece
© Authors: All rights reserved, 2023
https://doi.org/10.53243/ICEG2023-449

# Forensic Geotechnical, Hydrological and Hydrogeological Analysis of Instability Phenomena Occurred at a Waste Management Centre

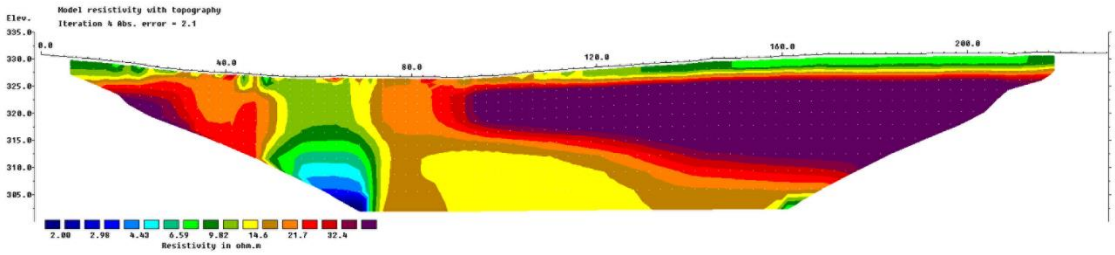
Within the site, a total of 11 electrical resistivity tomography (ERT) investigation profiles were conducted. The total profile length was approximately 2500 m. During the data acquisition phase for electric resistivity, the SYSCAL Pro Resistivity and IP device, produced by IRIS INSTRUMENTS, was used. The primary data was filtered to eliminate systematic errors using the ProSYS2 program, and subsequently the filtered data was modelled in the RES2INV program and the ERT-Lab1 program (Figure 5).

***Figure 5.*** *Inverse Model Resistivity Section*

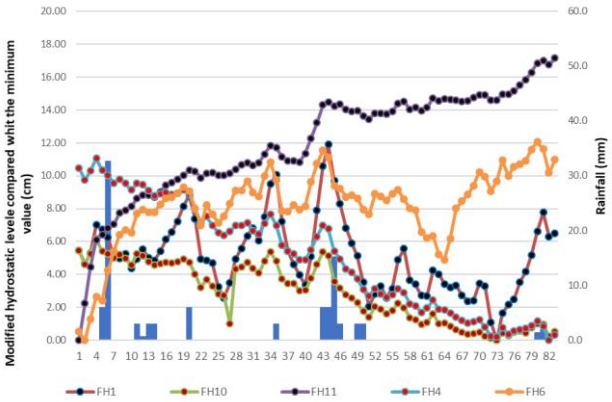
5 hydrogeological wells were monitored during a period of 90 days (autumn – winter time). The groundwater level and temperature were monitored using automated pressure and temperature data loggers (Figure 6).

***Figure 6.*** *Groundwater monitoring data*

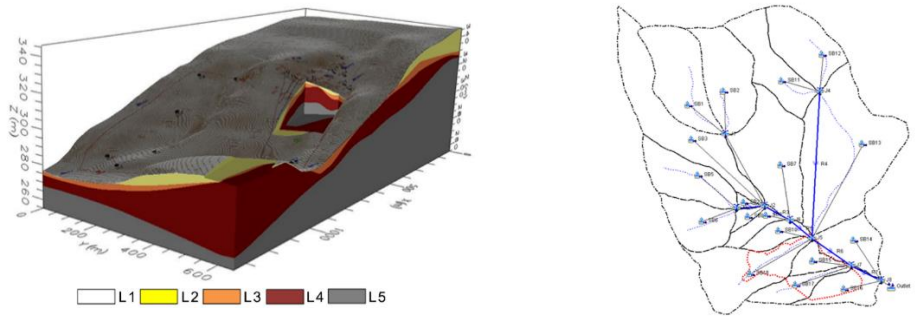
The geological model (Figure 7) has a rectangular shape, with the SW boundary set at a sufficient distance from the upstream limit of the WMC. Therefore, drainage works don't influence the boundary condition of hydraulic head imposed, as specified boundary condition within the hydrogeological model. The characteristics of the model are: (1) length L = 1352.245 m and width l = 646.961 m; (2) maximum ground elevation $Z_{max}$ = 350 m. The minimum elevation of the model was set 5.70 m below the minimum elevation of the marl deposits determined by the study drillings, namely $Z_{min}$ = 255 m.

Five layers were considered, from top to bottom: (1) L1-topsoil, (2) L2-silty clay, yellowish silty clay, yellowish-brown or greyish-brown, (3) L3-gravel with sand, with or without boulders in clay matrix, (4) L4-silty marl clay, yellowish-brown or greyish-brown silty clay marl and (5) L5-gray marl.

***Figure 7.*** *Geological 3D Model (left) and hydrological model scheme (right – with red line is the delineation of the WMC).*

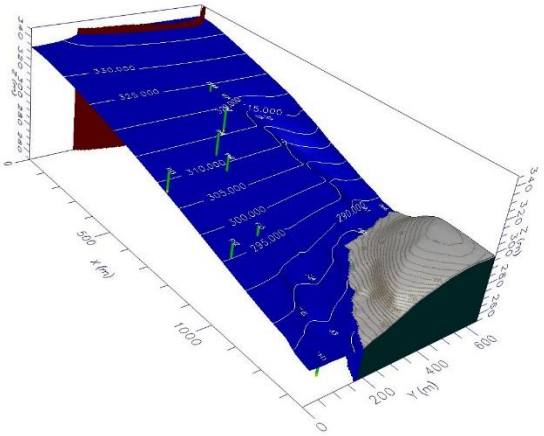
Figure 8 below presents the 3D representation of the groundwater level in the area, while Figure 9 shows the groundwater after drawdown.

***Figure 8.*** *3D representation of the groundwater table*

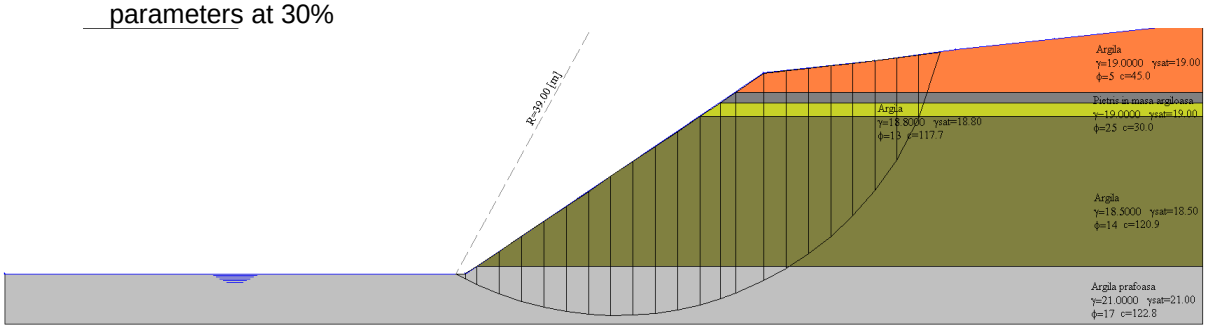
***Figure 10.*** *Results of stability analyses for the initially designed cut slope 1:1.5, no berms, GWL at GL, static conditions, parameters as determined in the initial geotechnical report.*
*Note: Clay (orange), Clayey gravel (grey), Clay (yellow), Clay (green), Silty clay (light grey)*

The results of the stability analyses performed for the man-made slopes (initial inclination 1:1.5) are shown Table 2. The initial design is not ensuring stable slopes and an inclination of 1:4 would have been required or to provide mechanical consolidation and drainage measures. More stability analyses have been performed for the situation after geometrical remodelling of the slopes (part of the slope with inclination 1:2.5), some of the results being also shown in Table 2.

Based on these results was concluded that even though the groundwater was the primarily cause of the instability phenomena and the design should have consider it, this has been superposed over basic design errors, as slopes were designed too steep and didn't consider the presence of swelling clays and that water can infiltrate through the contraction fissures, reducing drastically the shear strength parameters.

| Case no. | Description | Overall safety coefficient using characteristic values | | Analysis according to EN 1997 (over-design factor) Approach 3 (ODF = $F_s$/ $F_{s\ prescribed}$) | |
|---|---|---|---|---|---|
| Slopes 1:1.5 without berms (initial design – Figure 10) | | | | | |
| **1** | Circular slip, no GWL (as designed) | 2.33 | 1.89 | 1.33 | 1.43 |
| **2** | Circular slip, GWL at GL | 1.86 | 1.48 | 1.07 | 1.13 |
| **3** | Circular slip, no GWL, shear strength parameters reduced at 30% | 0.69 | 0.56 | 0.40 | 0.43 |

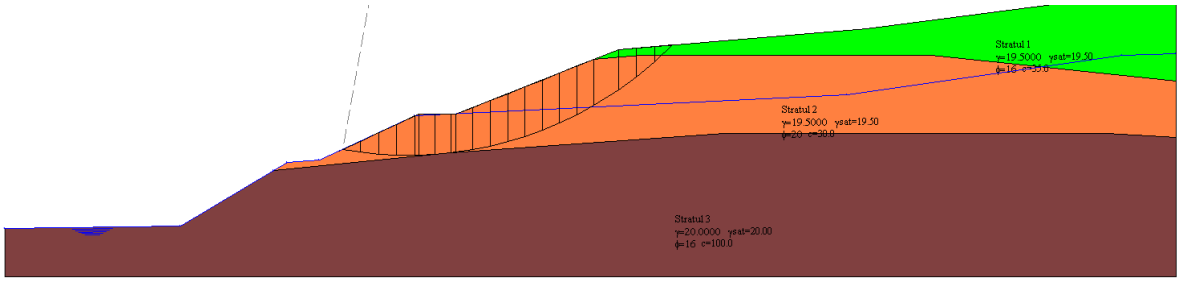
***Figure 11.*** *Results of stability analyses for the remodelled cut slope, GWL as measured, static conditions, parameters as determined in the final geotechnical report.*

| Case no. | Description | Overall safety coefficient using characteristic values | | Analysis according to EN 1997 (over-design factor) Approach 3 (ODF = $F_s$/ $F_{s\ prescribed}$) | |
|---|---|---|---|---|---|
| Remodelled slope – (Figure 11) | | | | | |
| **7** | Circular slip, GWL as measured | 2.41 | 1.77 | 1.38 | 1.37 |
| **8** | Circular slip, GWL at GL | 2.10 | 1.54 | 1.21 | 1.20 |
| **9** | Circular slip, no GWL, reduced shear strength parameters at 30% | 0.97 | 0.70 | 0.55 | 0.54 |

The remodelling intervention of the slope (berms and partially less steep slopes) was not sufficient as the stability analyses show it and also what happened further on site. Therefore, were required more interventions, consisting of: 39 sub-horizontal drains for collecting groundwater infiltrations, 46 segments of reinforced concrete retaining walls each supported by 5 – 6 micro-piles and 3 – 4 pre-tensioned ground anchors, disposed in zigzag on the berms (at the lower and middle section of the slope). Despite these extensive consolidation measures the swelling characteristic of the soil has still not been considered and no detailed stability analyses performed. When analysing the consolidation measures through the stability analyses presented here-above it was concluded that in some sections the retaining walls were not properly disposed for intercepting the slip surfaces, leaving many areas of the upper part of the slope not covered. This has been confirmed by the monitoring of ground displacements showing that the movement is still active and that signs of continuing instability phenomena have been identified. The consolidation measures proved to be insufficient as the retaining walls were not continuous, they were not able to intercept in all sections the slipping surfaces and their effect was not checked using stability analyses, in fact their design being made as for a normal retaining structure, not for one supposed to stop a landslide. Drainage works have been poorly designed in absence of a proper hydrogeological investigation.
